## **Control of Slippery Conditions on Mining Roads Through Layering with Crusher Reject Material on the Hauling Road from Pit to Rom Pit Basalt PPA During Q4 2025**

PT Putra Perkasa Abadi Jobsite Maruwai Coal, Indonesia

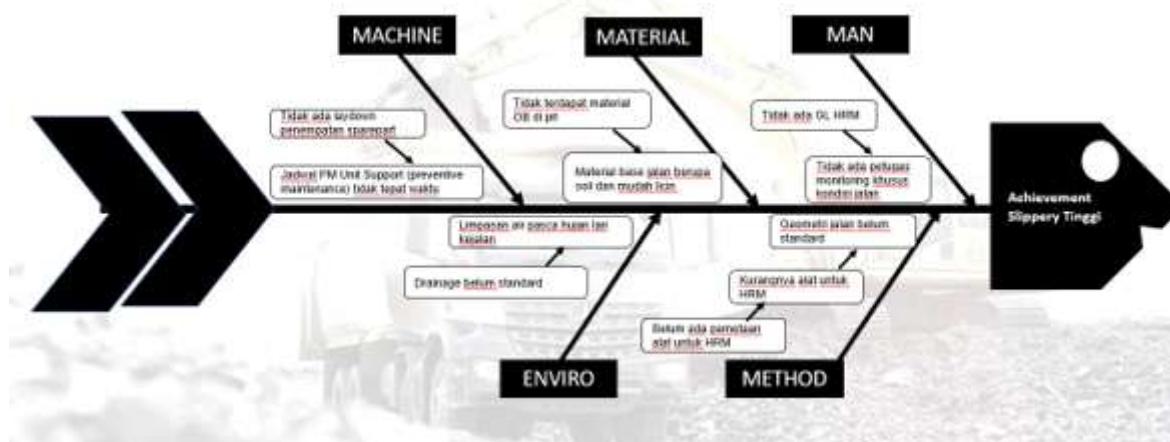
**Figure 2. Cause-and-Effect Analysis of High Achievement Slippery**

The results of the analysis showed that all identified factors were classified as the dominant root causes. Wide conditions and non-standard road grades have been proven to limit the movement of hauling units and increase the risk of slipping. The absence of soil carrying capacity testing causes the base of the fast road to be damaged, especially when it rains. A non-standard drainage system exacerbates slippery conditions as water runoff flows into the road body. The absence of a maintenance-specific excavator unit slows down the repair response, while the unavailability of hard materials in the pit hinders the formation of a stable road base. In addition, the lack of socialization of slippery calculations also contributes to the lack of optimal control of road conditions.

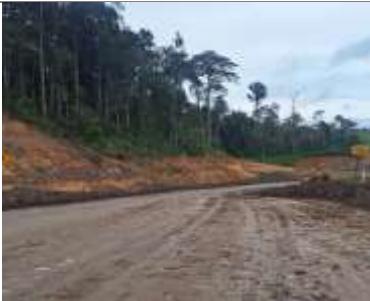
No	Repair Activities	Implementation of Improvements	Documentation
1	Excavator repairs drainage

The implementation of the improvement plan is shown in Table 7, which illustrates that all key activities have been implemented according to the plan. Activities include drainage repair and normalization, soil carrying capacity testing using DCP, spreading and compaction of reject crusher materials, to socialization of AWR roads and safety aspects to road users. This consistent and integrated implementation ensures that improvements focus not only on the road surface, but also on technical aspects and operational behavior.

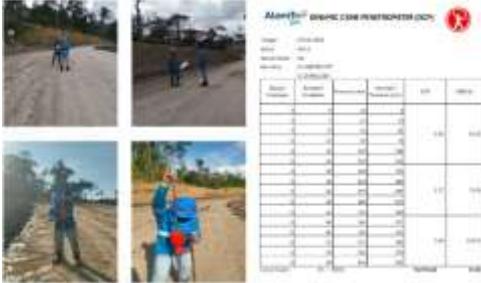
2	DCP Testing

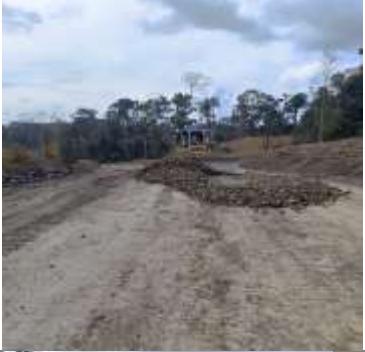
3	Dozer Spreads Reject Material

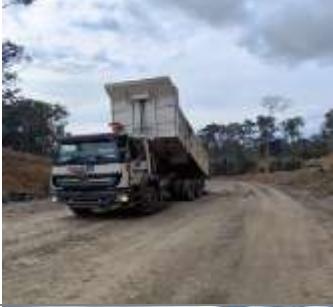
4	Unit Dump Truck Dumping material Reject

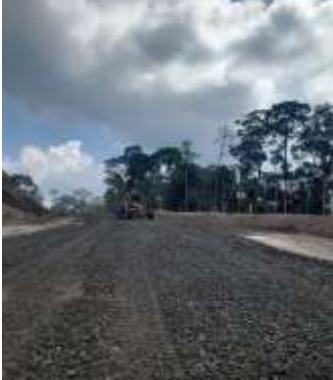
5	Unit Grader Spreads reject material
