## Vibration Based Fault Analysis of a Centrifugal Cooling Water Pump Using FFT and Pressure Parameters

This study was conducted at PT Indah Kiat Pulp & Paper Tbk., Karawang Unit, West Java, focusing on the cooling water pump system, which consists of four identical centrifugal pump units. However, the scope of this research was limited to one unit, namely pump U2053.

The pump used in this study is a centrifugal pump manufactured by Andritz China, type ACP300-400.3F DD. The pump has a flow rate of 1250 m<sup>3</sup>/h, a head of 30 m, and is driven by a 160-kW motor operating at 1485 rpm. The impeller diameter is Ø 386/70 mm, and the unit was manufactured in 2024.

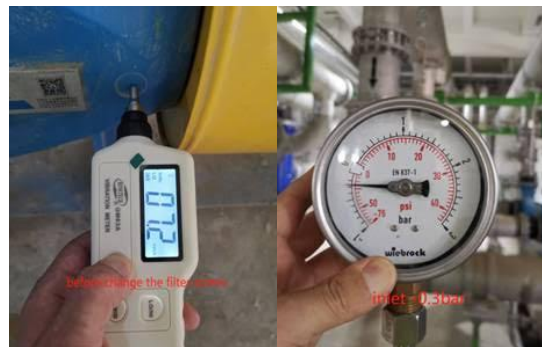
**Figure 1.** Direct measurement data

As shown in Figure 1, the initial measurements consist of both vibration and suction pressure results. The vibration data are presented only as overall numerical values without FFT spectrum visualization, limiting the ability to identify specific fault characteristics. Meanwhile, the suction pressure measurement indicates a negative pressure condition at the pump inlet. Therefore, in this study, further vibration analysis will be conducted using measurement tools equipped with Fast Fourier Transform (FFT) capabilities to obtain detailed frequency-domain information for more accurate fault diagnosis.

This issue was identified in four centrifugal pumps in the cooling water system at PT. Indah Kiat Pulp & Paper Tbk., Karawang, following utility commissioning in June 2025. Field observations revealed abnormal operating conditions, including high noise levels and negative suction pressure. Pressure measurements recorded  $-0.3$  bar ( $-30$  kPa), indicating a significant pressure drop that may approach or fall below the fluid's vapor pressure. Under such conditions, cavitation may occur, leading to increased vibration, potential damage, and efficiency loss (Gulich, 2019). Initial vibration measurements showed a high level of  $7.2$  mm/s; however, they provided only overall values, without the frequency-domain characteristics required for accurate fault identification.

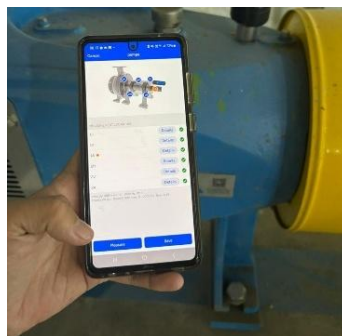
**Figure 3.** SKF Quick Collect application

The measurement results were displayed using the SKF QuickCollect application, connected via Bluetooth, as shown in Figure 4. The application provides overall vibration values and FFT-based spectra, and supports real-time monitoring, data storage, and trend analysis. Therefore, integrating the SKF Vibrometer and the SKF QuickCollect application provides an efficient and reliable approach for vibration data acquisition and analysis, enhancing the accuracy of fault identification in centrifugal pumps within a predictive maintenance framework.

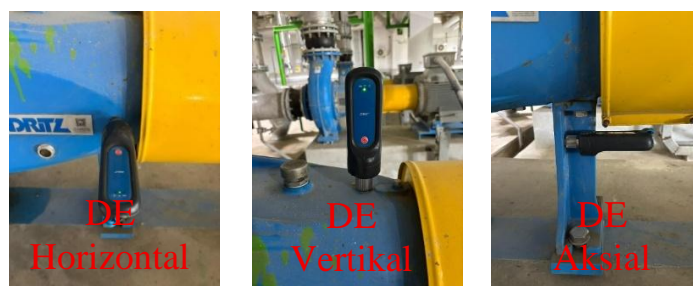
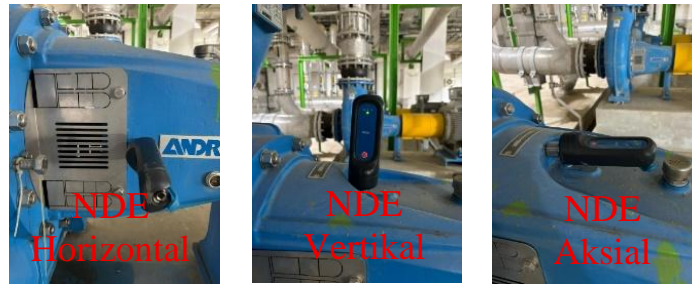
**Figure 4.** Measurement Point

Vibration measurements were then performed using an SKF Vibrometer at critical locations, namely the Drive End (DE) and Non-Drive End (NDE), to capture vibration behaviour from different structural points. Measurements were taken in horizontal, vertical, and axial directions.

As illustrated in Figure 3, the measurement points represent the locations for vibration data acquisition on the centrifugal pump using an SKF Vibrometer.

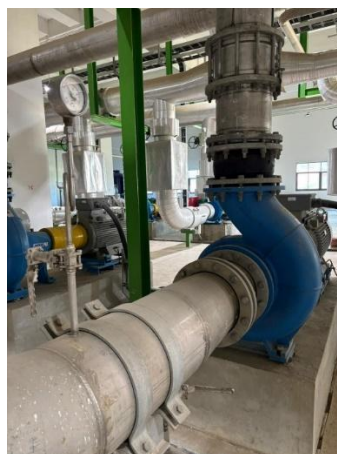
**Figure 5.** Pressure Gauge Position

In addition to vibration measurements, this study utilizes pressure data obtained from a pressure gauge installed on the suction side of the pump, as shown in Figure 5. The gauge measures fluid pressure to evaluate hydraulic conditions, particularly to detect negative pressure that may trigger cavitation.

The recorded data indicate negative suction pressure, representing a pressure drop below atmospheric conditions. This condition is critical, as it may lead to vapor bubble formation when the local pressure approaches or falls below the fluid's vapor pressure.

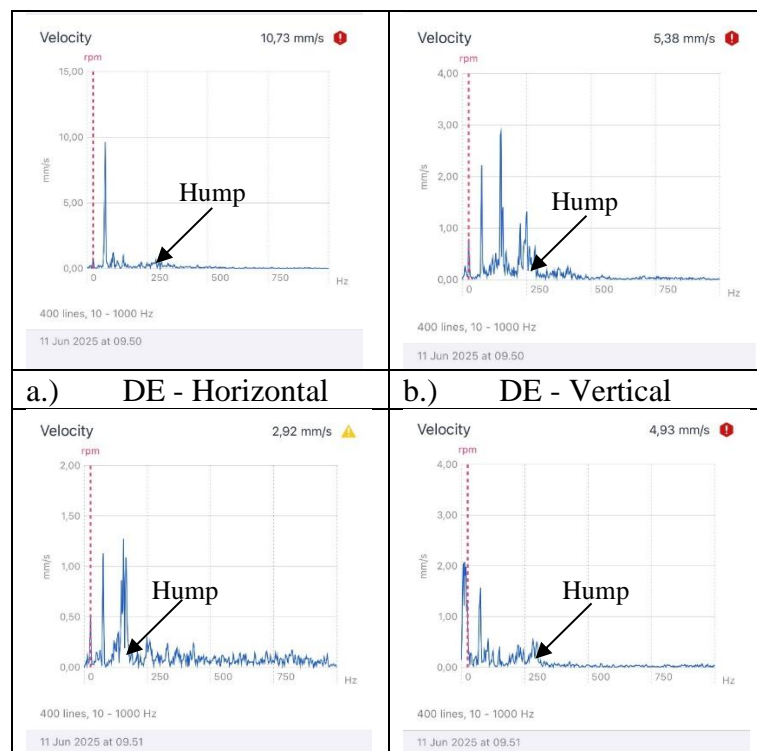
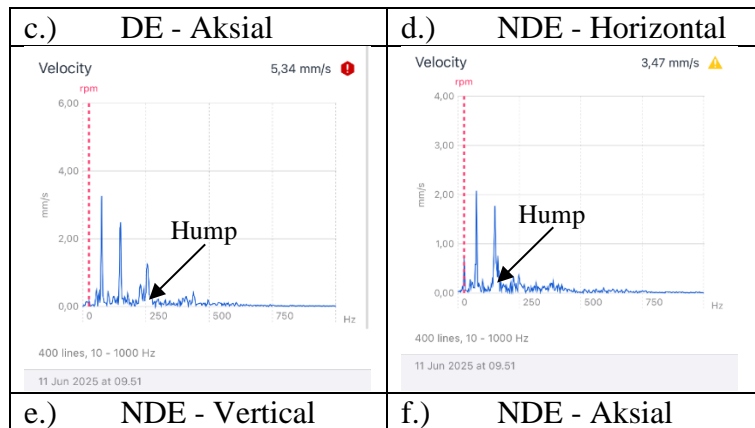
**Figure 6.** Result check vibration

As shown in Figure 6, all measurement points exhibit similar spectral characteristics. The vibration velocity values at all points exceed the limits defined in ISO 10816-3, namely 2.80 mm/s (alert) and 4.50 mm/s (danger), indicating that the pump operates under abnormal conditions with a high potential for severe mechanical or hydraulic faults.

The consistent spectral patterns across all measurement points suggest that the vibration phenomenon is not localized but rather system-wide. This indicates the presence of a dominant excitation source affecting the overall dynamic behavior of the pump system.

Correlation with the FFT spectra in Figures 6 (a)–(c) shows that, in addition to the dominant peak at  $1\times$  rotational frequency, there is a noticeable increase in broadband energy forming a hump in the mid- to high-frequency range. This pattern is most prominent in Figure 6(a) (DE-Horizontal), which shows the highest vibration value, followed by lower intensity in Figure 6(b) (DE-Vertical), while Figure 6(c) (DE-Axial) exhibits more distributed energy with lower amplitude.

These spectral characteristics are indicative of cavitation, where the formation and collapse of vapor bubbles generate random broadband vibration, in contrast to discrete peaks typically associated with mechanical faults such as unbalance or misalignment [11], [9].

Therefore, based on the vibration severity and FFT spectral patterns, it can be concluded that the pump at the Drive End (DE) is experiencing developed cavitation.

Referring to the FFT spectra in Figures 6 (d)–(f), the vibration signals exhibit not only a dominant peak at the rotational frequency ( $1\times$  RPM) but also broadband energy forming a hump in the mid-frequency range. This pattern is evident in Figure 6(d) (NDE-Horizontal) and becomes more pronounced in Figure 6(e) (NDE-Vertical), consistent with the highest vibration value. Figure 6(f) (NDE-Axial) shows a more distributed spectrum with lower amplitude, yet it still indicates non-discrete vibration energy.

These spectral characteristics are indicative of cavitation, in which the formation and collapse of vapor bubbles generate random broadband vibration, in contrast to the discrete harmonic peaks typically associated with mechanical faults.

Therefore, based on the vibration severity levels and FFT spectral patterns, it can be concluded that the pump at the Non-Drive End (NDE) is also experiencing developed cavitation. The consistent occurrence at both DE and NDE indicates that the vibration source affects the system as a whole.

The FFT spectra at all measurement points (Figure 6 a–f) show a broadband energy forming a characteristic “hump” in the mid- to high-frequency range. This spectral pattern is not typical of mechanical faults such as unbalance or misalignment, but is more consistent with cavitation characteristics.

Therefore, it can be concluded that the pump is experiencing fully developed cavitation across the system, which is associated with hydraulic conditions such as low suction pressure or insufficient Net Positive Suction Head (NPSH).

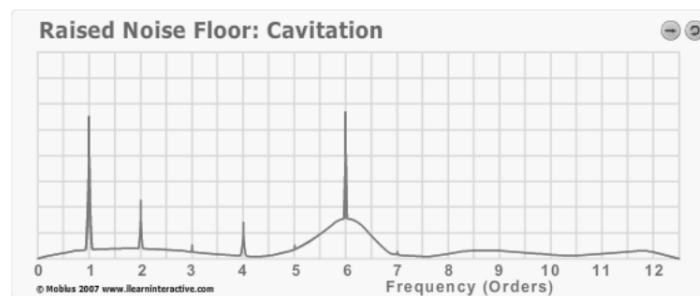
**Figure 7.** Mobius Institute Quick Reference Guide

Based on the FFT spectral analysis at both the Drive End (DE) and Non-Drive End (NDE), the vibration patterns exhibit consistent characteristics across all measurement points. When compared with the reference spectrum in Figure 7, adapted from established vibration analysis guidelines, a similar broadband energy distribution is observed, accompanied by a characteristic hump in the mid- to high-frequency range.

This spectral signature is typically associated with cavitation phenomena rather than mechanical faults such as unbalance or misalignment, which are generally characterized by distinct harmonic peaks at specific multiples of the rotational frequency. The presence of broadband high-frequency content further supports the occurrence of hydraulic instability, driven by vapor bubble formation and collapse within the pump.

The agreement between the measured FFT results and the reference spectral pattern confirms the reliability of the diagnostic approach used in this study and strengthens the identification of cavitation as the dominant fault mechanism in the system.

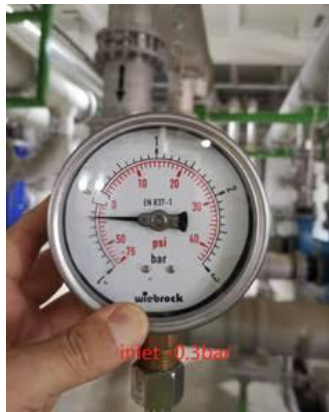
**Figure 8.** Pressure Suction

To improve diagnostic accuracy, vibration analysis results are correlated with suction pressure data. As shown in Figure 8, the suction pressure is negative, indicating a significant pressure drop that may approach or fall below the fluid's vapor pressure, creating conditions conducive to cavitation.

From a hydraulic perspective, this condition is related to the Net Positive Suction Head Available ( $NPSH_a$ ). A decrease in suction pressure reduces  $NPSH_a$ , and when it approaches or falls below the required NPSH ( $NPSH_r$ ), cavitation may occur. Thus, the observed negative suction pressure indicates a reduction in  $NPSH_a$ , which is indicative of potential cavitation.

When correlated with the FFT spectrum, which shows broadband vibration and a hump in the mid- to high-frequency range, the results suggest that the dominant vibration source is related to hydraulic phenomena. This observation is consistent with diagnostic guidelines from the Mobius Institute, which characterize cavitation by non-discrete spectral patterns and elevated broadband energy rather than distinct harmonic peaks.

Therefore, the combination of negative suction pressure, reduced  $NPSH_a$ , and broadband vibration characteristics indicates that the pump is likely experiencing cavitation. This integrated approach demonstrates that combining vibration and pressure analysis provides a more reliable method for identifying the root cause of abnormal vibration in centrifugal pump systems.
