Evaluation of the Elements and Characteristics of the Facades of Cultural Heritage Buildings in the Context of Colonial Architecture

Hagakita Bank Building

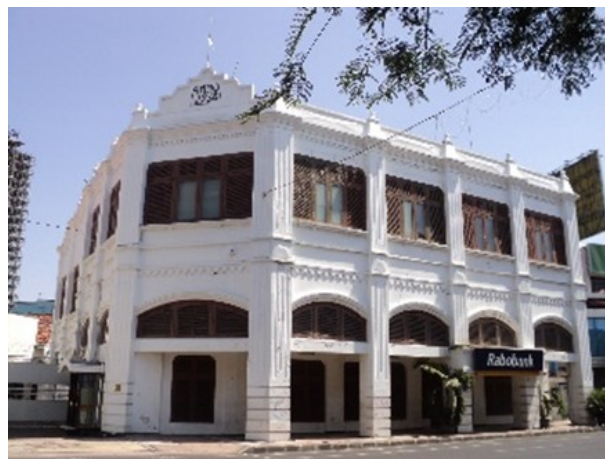
The Bank Hagakita building is located on Jalan Tunjungan number 60 Surabaya City, currently an empty building that does not have a special function, so there are no special activities carried out in it. This building is one of the modern colonial buildings in Surabaya, its status as a cultural heritage building makes this building need to be considered because it is related to building the identity of the historical area. There is not much information available as to when this building was built. Simple information can be seen on the plaque attached to the building which is estimated to have existed since the 1912s. Thus, this building can be categorized as a transitional architectural style. The building looks simple but majestic and has ornamental details on its façade.

Image 1. Hagakita Bank Building

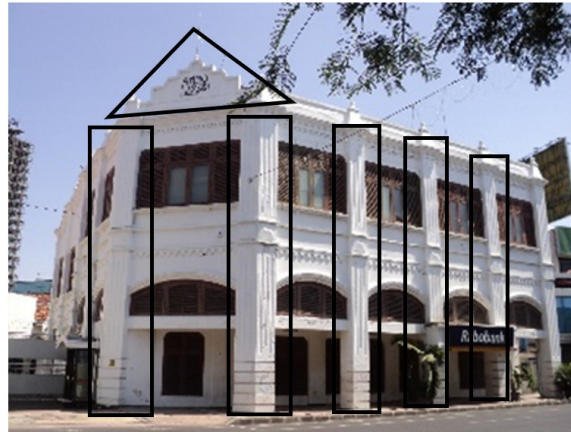
The shape of a building is a variable related to regularity and complexity Iffiyah, (2022). The Bank Hagakita building has a spacious portico and a sturdy monumental façade. The building is decorated with large neoclassical-style columns. Compared to the building style of imperial architecture, the building of the Hagakita Bank is simpler and less complicated. The large columns on the outside of the building make it look sturdy. There is a triangular gevel inside this building. The ends of the gevel are also decorated with a circular shape called a geveltoppen (gable roof decoration) (Figure 2).

Image 2. Building Shape of Bank Hagakita
Source: Researcher, 2024

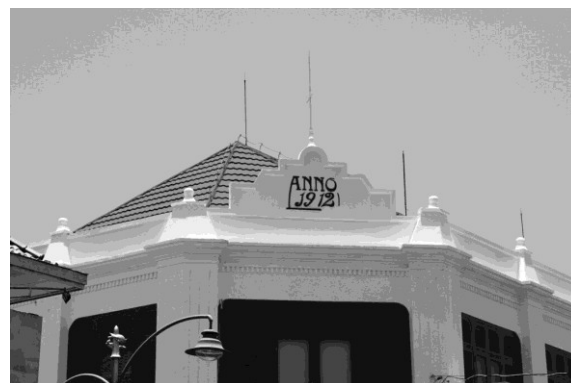
The shape of the roof of the building in the Hagakita Bank Building uses a low-slope shield roof model. Basically, the function of the roof is to limit visibility and provide a sense of security against the infinite emptiness of the sky (Wiryomartono, 2014). The combination of the low slope of the roof, the elevated shape of the building and the presence of walls at the top of the building make the roof of this building invisible to the human eye.

Image 3. Roof of Bank Hagakita Building
Source: Pinterest, 2025

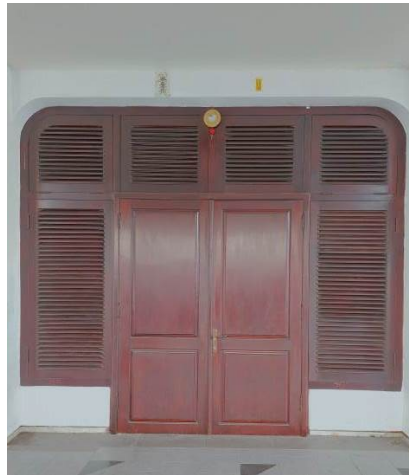
openings are doors and windows in buildings (Dinç Kalayci & Bilir, 2016). The design of doors and windows in this building is in the form of a large wooden grille. This reflects the appearance of doors and windows in the colonial era.

Image 4. Bank Hagakita Building Window
Source: Researcher, 2024

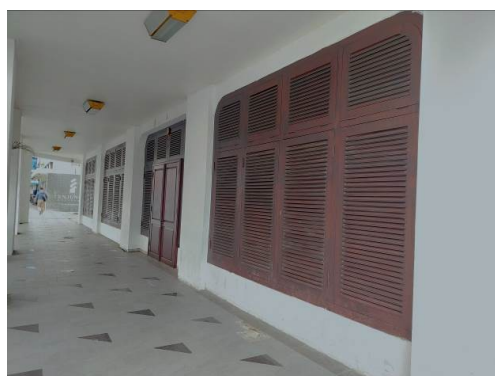
The color of the Bank Hagakita Building does not use the natural color of the material, but the concept of coloring from the basic material of this natural color is maintained in this building. The colors used in the Hagakita Bank building are dominated by white and brown paint on the door and window frames. The dominant white color of this building is a characteristic of colonial buildings in the Nieuwe Bouwen style. The color white also symbolizes calm and peace (Arifianto, 2009).

Image 5. Colors of Bank Hagakita Building
Source: Researcher, 2024

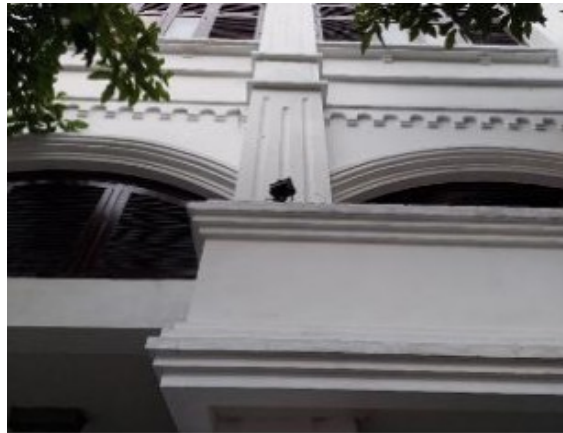
The decoration on the Hagakita Bank building consists of carvings on the façade of the building, decorative lights with colonial designs, and carved pipes. The carvings add a classic/ancient impression to the cultural heritage building.

Image 6. Carvings on the façade of the Bank Hagakita Building
Source: Researcher, 2024

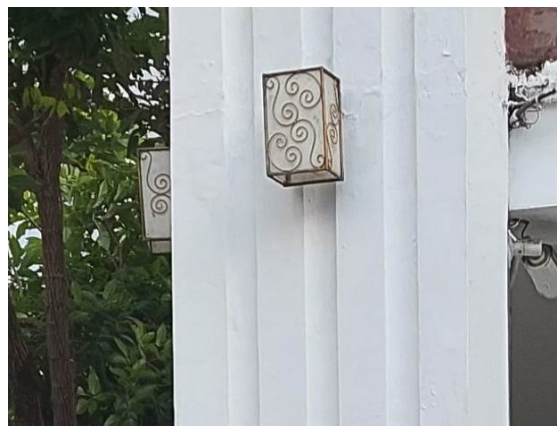
Image 7. Decorative lamps with colonial design
Source: Researcher, 2024

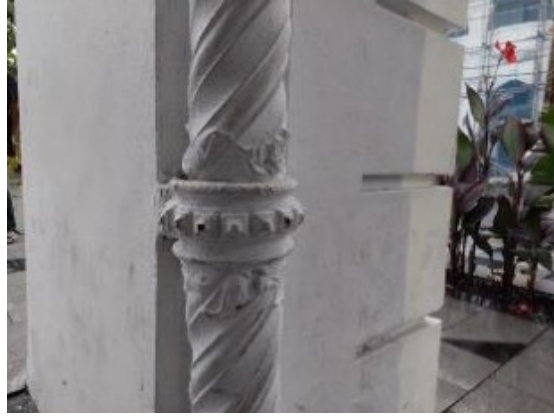
Image 8. Engraving on the pipe of the Hagakita Bank Building
Source: Researcher, 2024

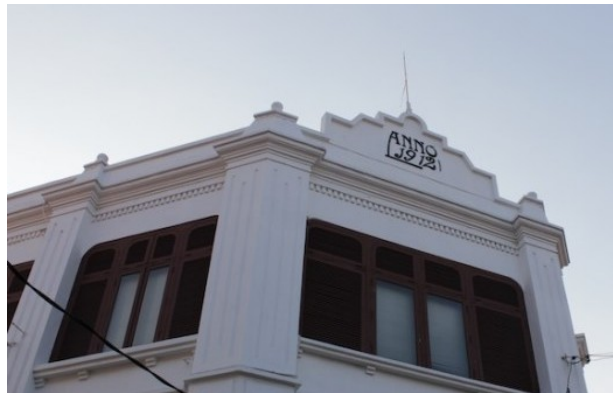
Decorations on the roof of the building were also added in the form of Windwijzer/Wind Pointer placed above the nok level which can rotate according to the direction of the wind.

Image 9. Windwijzer Bangunan Bank Hagakita
Source: Researcher, 2024

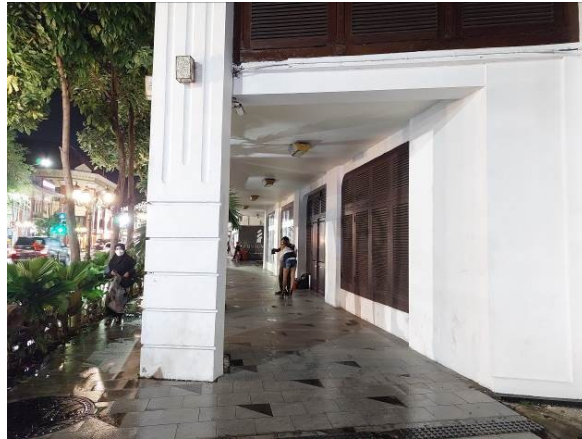
The use of permanent materials such as brick, concrete, iron, cast iron is one of the characteristics of colonial buildings. The materials used in the Hagakita Bank building are bricks and concrete, besides the materials on the doors and windows use wood.

Image 10. Building Materials of Bank Hagakita
Source: Researcher, 2024

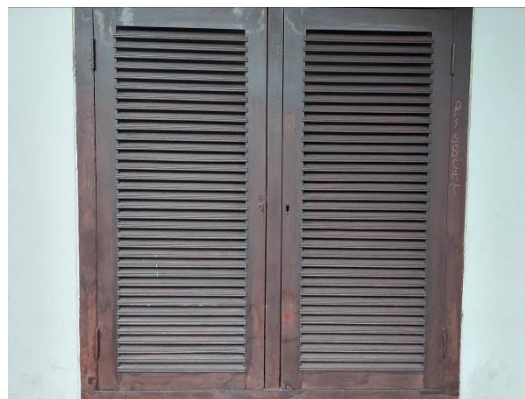
Textures can be formed from the density of the layers on the façade, the softness and hardness of the layers, as well as the contrast and similarity of the layers in view (Utaberta et al., 2012). In visual art, texture is an important element to give a smooth, rough, and various other feelings. In the Hagakita Bank building, textures are found in the natural materials produced from wood and carvings formed on the façade. The grooves and carvings on the wooden windows and doors create a special pattern when touched.

Image 11. Texture details resulting from wood material
Source: Researcher, 2024
